Manhole Inspection Summary

Manhole # S27M__036MH

Location Address: **838 Parkin St**

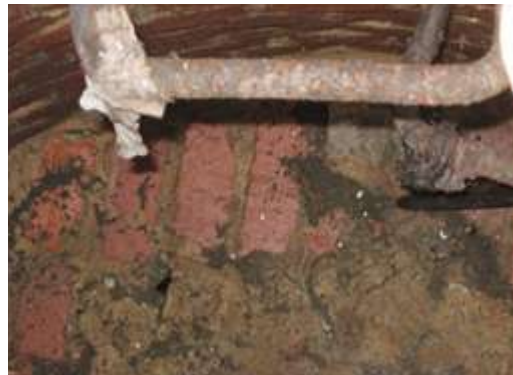
Defect 3

☒ **Evidence Of Surcharge** Depth: **4** (ft.) ☐ Active Surcharge Present

evidence of surcharge

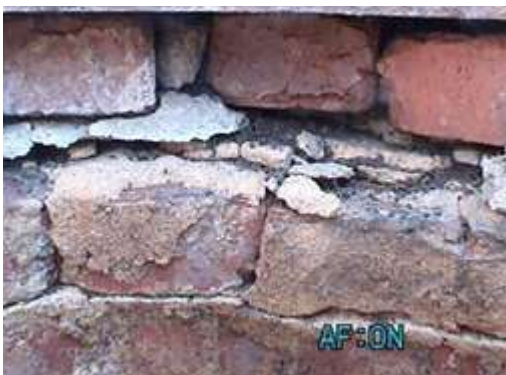
Defect 1

Condition: ☐ Sound ☒ **Cracked** ☐ Root Intrusion ☒ **Loose Brick** ☐ Deteriorated

chimney cond loose bricks, cracked, mortar

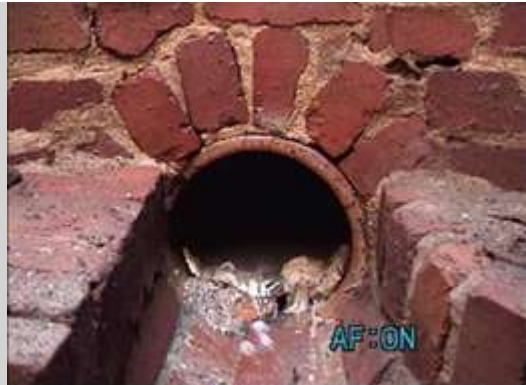
9 O'Clock Inflow

Deposits: ☐ None ☐ Mud ☐ Sludge ☒ **Debris** ☐ Grease

Silt Depth: **2** (in.) Deposits Extent: **Medium**
